## RECALL: "TANGO" connector incorrect marking

mod. KONG TANGO # 715.000

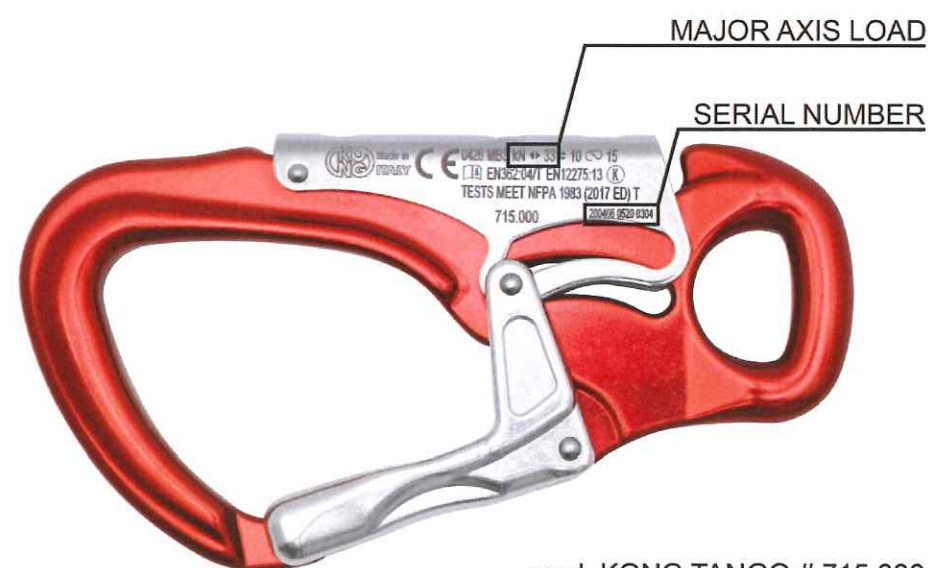
The connectors in question are the **BLUE** and the **RED** "TANGO" connectors placed in the market starting from 5<sup>th</sup> February 2020 with the serial number:

- 200315 0220 XXXX (BLUE color);
- 200466 0520 XXXX (RED color).

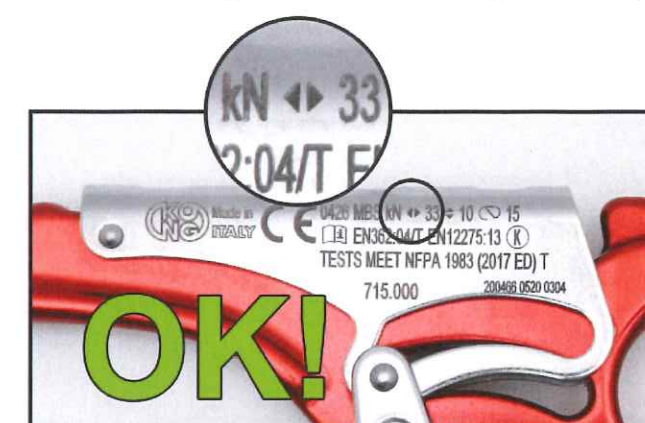
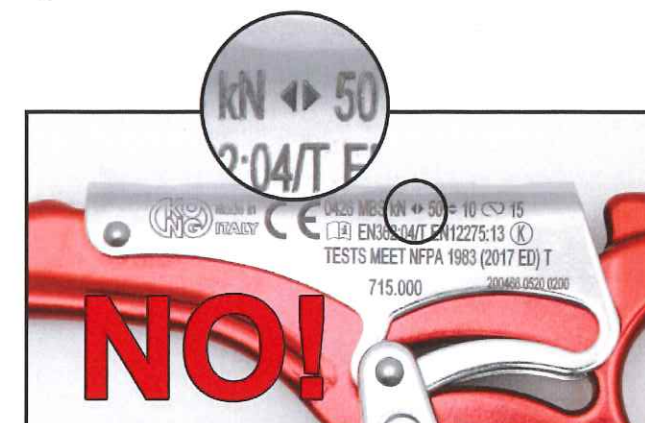
The connector shows an incorrect value of 50kN instead of the correct strength rating of 33kN.

Improper marking may lead users to apply a load up to 50kN causing possible breakage of the connector, that is tested to a maximum load of 33kN.

Verify that the strength marking along the major axis with the gate closed is 33kN.

Below the examples of correct marking, and wrong marking.

In order to avoid any possible misuse (i.e. overloads), the connectors with the wrong marking (50kN) shall be taken out of service, and replaced.

KONG will collect and replace the connectors with others of the same model, but correctly marked (33 kN).
